# Lower Colorado River Multi-Species Conservation Program

## Beal Lake Conservation Area

## 2016 Annual Report

September 2018

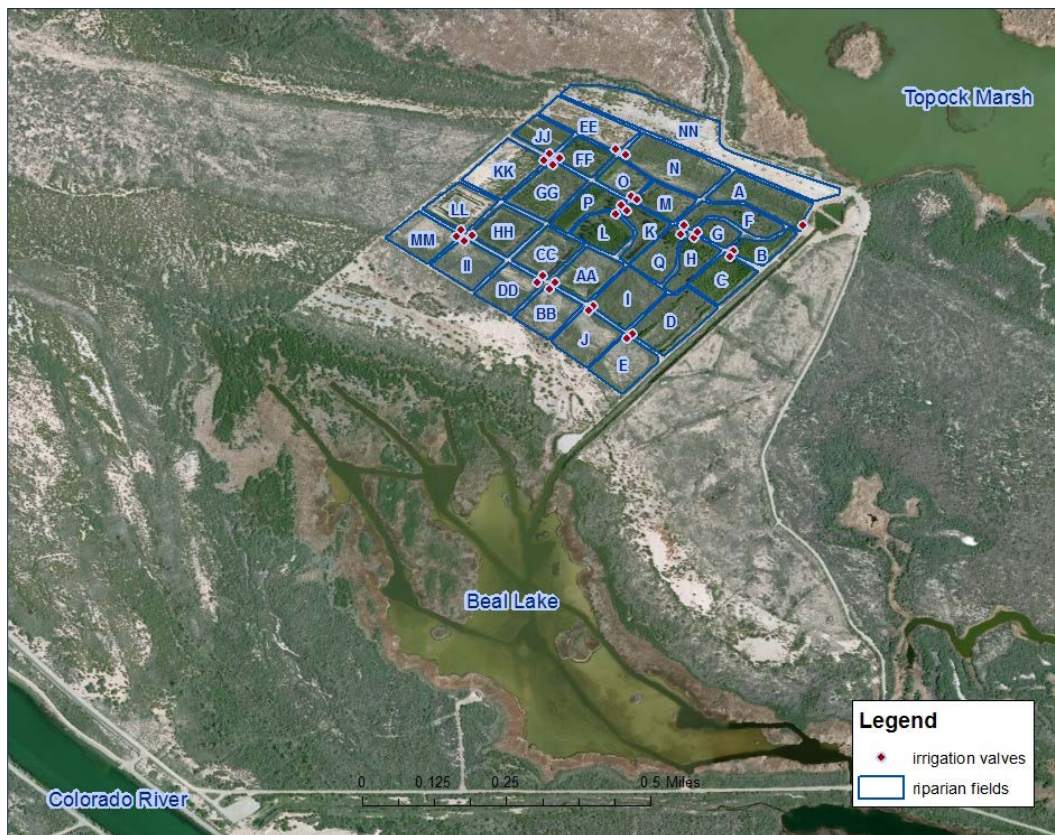
Figure 3.—Overview of the BLCA.

The fields at the BLCA are independently flood irrigated from one alfalfa valve positioned in a corner of each field (figure 3). The fields are irrigated on a schedule that prioritizes establishing newly planted vegetation, creating microclimate conditions for LCR MSCP species, and preventing salts from accumulating in the soil. Fields recently planted or seeded with native vegetation are irrigated on a weekly basis, while fields with established stands of trees are either frequently irrigated to create microclimate conditions for covered species or are put on a reduced irrigation schedule to merely keep salts from accumulating in the soil.
